RCRA Enforcement Inspection

Bayonne Barrel and Drum
Newark, New Jersey

NJD009871401

June 2, 1988

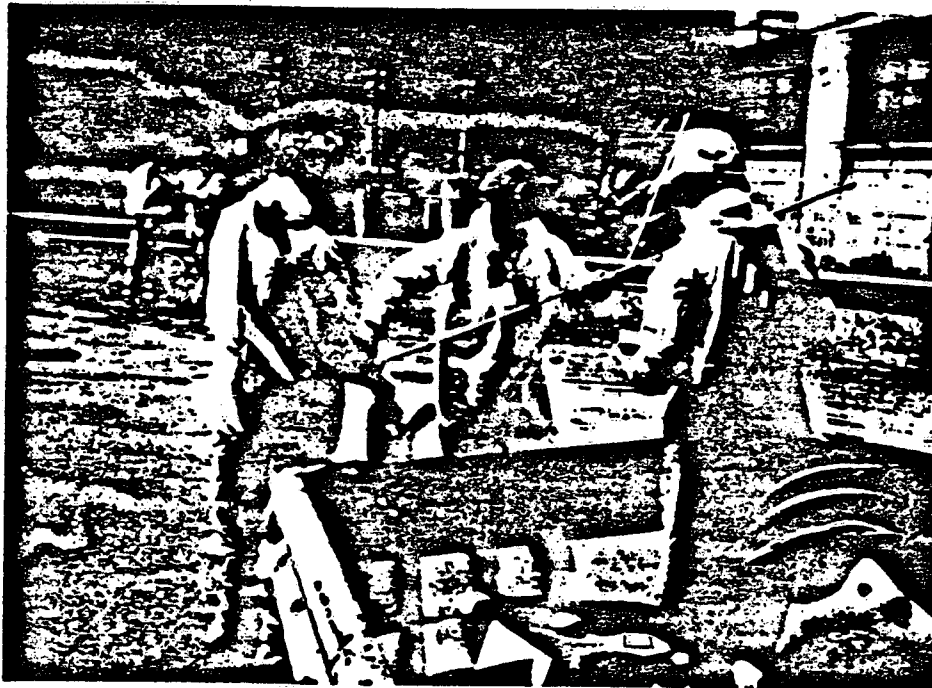
Sample #112207 - Aqueous samples were collected from an underground tank near the toluene pump. The sample was collected by taping an I-Chem Series 300 glass jar to an aluminum rod. The sample was collected in this manner due to the size of the access standpipe. In addition, the aluminum rod was shaped to fit the angled opening of the tank. See picture #3, which illustrates sampling of the underground tank.

#3. Sampling underground tank.

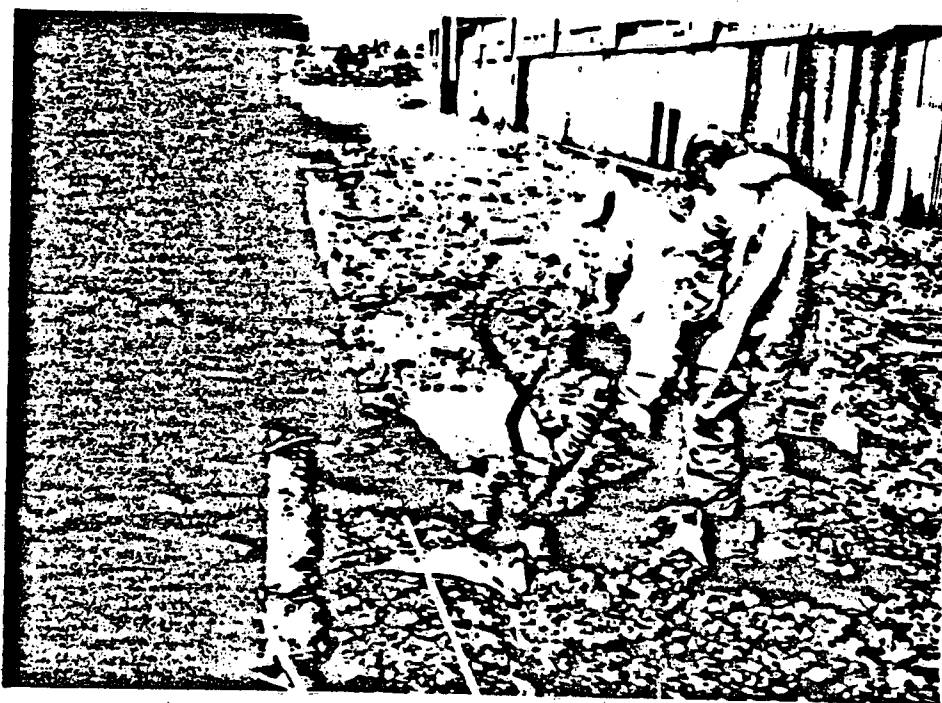
Sample #112208 - In addition to collecting ash samples from the courtyard, aqueous samples were also collected as depicted in photograph #4. Ponded water samples were collected in a low lying area adjacent to the courtyard ash pile and incinerator. Sample collection technique was by direct filling an I-Chem Series 300 glass jar and pouring into the appropriate sample containers.

#4. Collection of aqueous samples from courtyard area. Item #2 on attached site map.

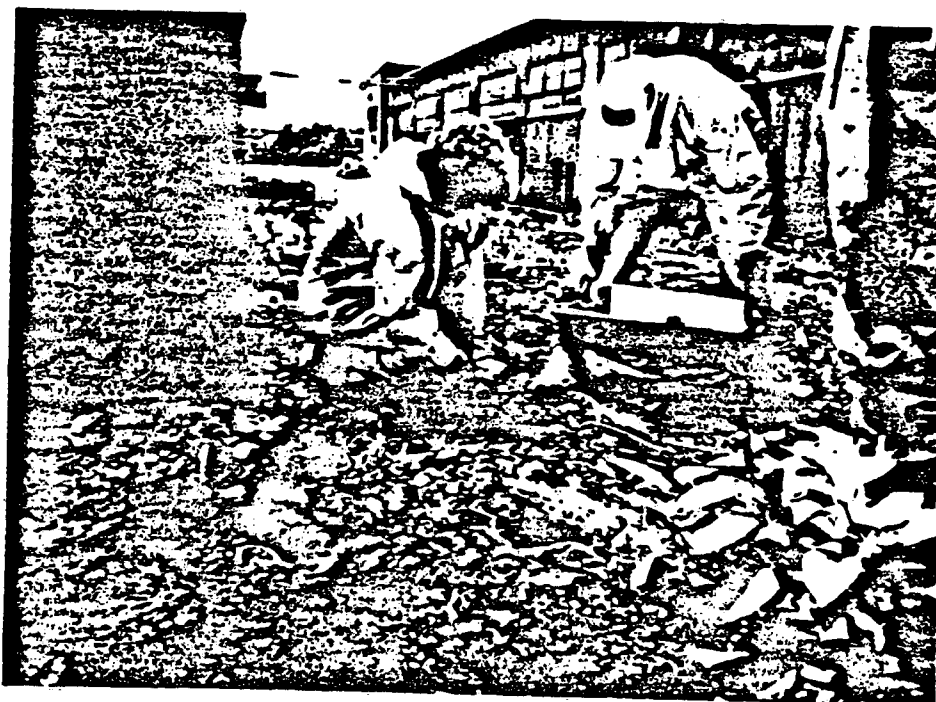
Sample #112202 - Courtyard area ash sample collected at random using the same techniques as listed in sample #112201. Photographs #5 - 9 illustrate the sample location and collection techniques. Make special notice of the various colors encountered in the ash pile and sample collected.

#6. Close-up of ash pile in courtyard, similar to photo #5.

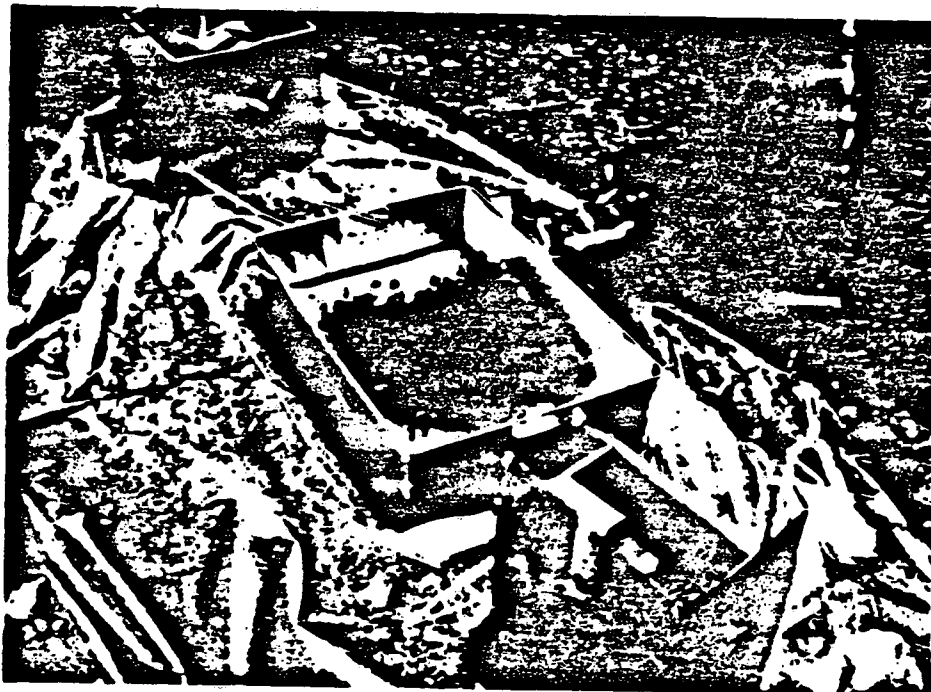
#7. Ash from courtyard area ash pile, ready for compositing.

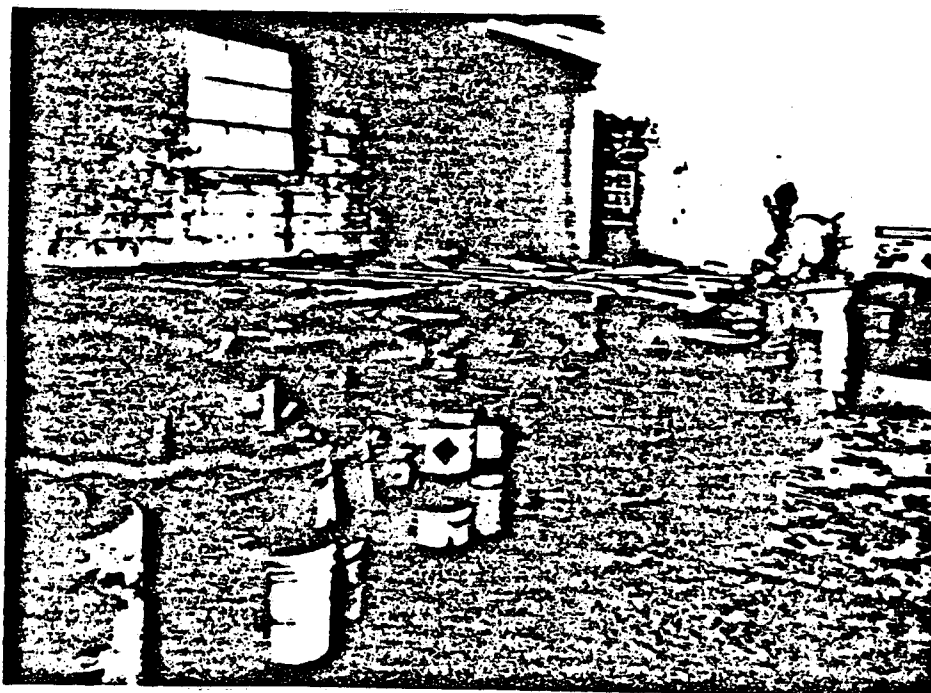
Sample #112213 - An aqueous sample was collected from a "RED" drum in the drum and ash storage room as depicted in photographs #11 - 12. Level B PPE was worn due to the presence of high concentrations of unknown organic contaminants. The drum was sampled using a precleaned, dedicated teflon bailer. Pictures #13 - 14 indicate the particular red drum which was sampled and other drums in the immediate area. Note the condition of the drums in all four photographs. Most of the drums contained ash which looked similar in nature to the ash pile in the center of the room. However, some of the drums contained liquids of unknown content. Many of the containers were in very poor condition, some with holes and a few inverted to prevent their contents from leaking onto the floor.

The drum and ash storage room contained many drums, approximately 100-150, which were not marked as a hazardous waste and were apparently stored in excess of 90 days.

#12. Overview of some of the many drums in the drum and ash storage room. Note condition of drums and old labels.

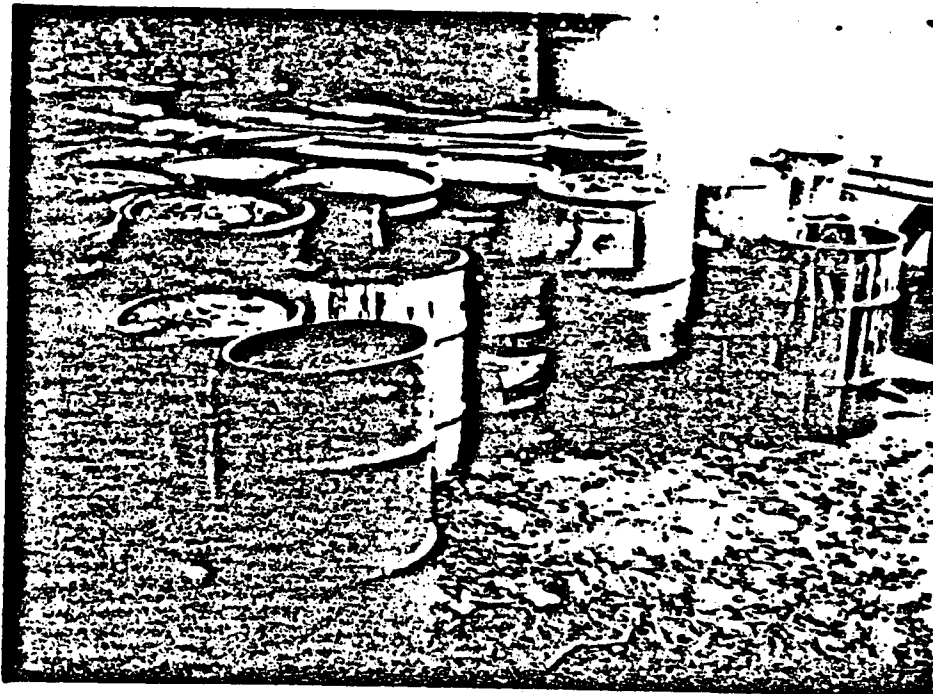
#14. Another view of drums in the drum and ash storage room.

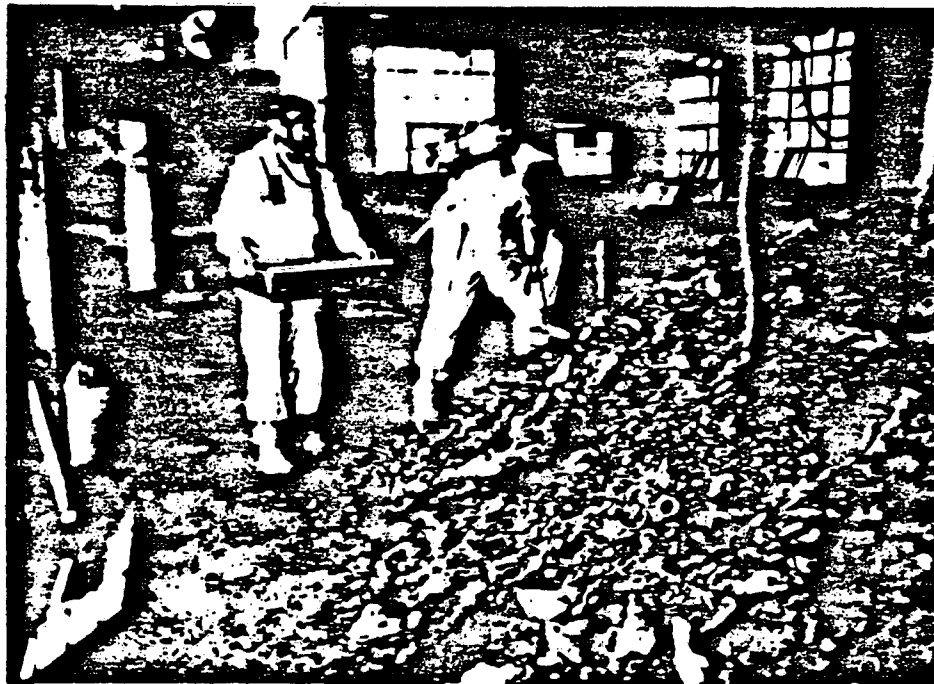
Sample #112203 - Drum and Ash storage room ash sample collected in a manner identical to that listed in sample #112201. Level B personal protective equipment (PPE) was worn in this area due to the presence of hazardous organic vapors, as indicated by air monitoring equipment. Pictures #15-16 illustrate sampling technique and level of protective equipment required.

#15. Sampling the ash pile in the drum and ash storage room. Note presence of drums in background.

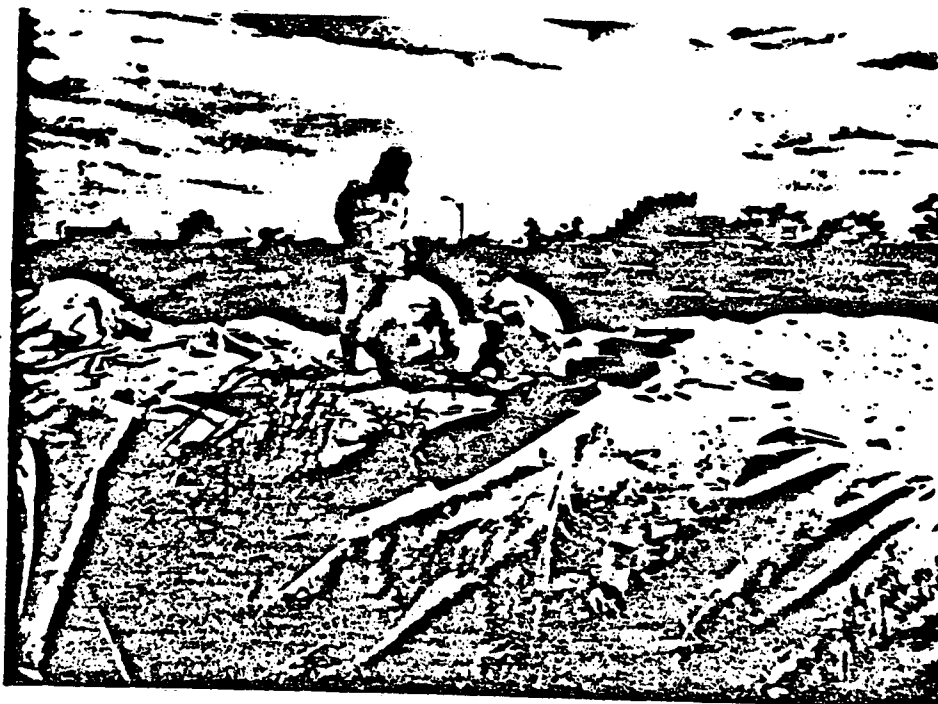
Sample #112212 - This sample number represents the "EAST" half of the waste ash pile near the drum storage area. Photograph #18 depicts sampling the "EAST" half of the ash pile while wearing Level C PPE. Sample collection techniques were the same as in sample #112204. A series of random grab samples were collected using a dedicated polypropylene scoop and then composited in a stainless steel tray. After the sample was thoroughly mixed, the respective sample containers were filled.

- #18. Sampling East half of the ash pile. Samples were collected at random and manually composited in a stainless steel tray.
